THE CITY HALL OF CAMPOSANTO AND THE CONSERVATION OF ITS DECORATIVE CONCRETE FINISHING

by Alessandra Alvisi,
Gian Carlo Grillini

From the direct observation and the instrumental analysis to the restoration project of the monument: the design path through the knowledge of an interesting example of XX century architecture, towards the elaboration and realization of conservation works

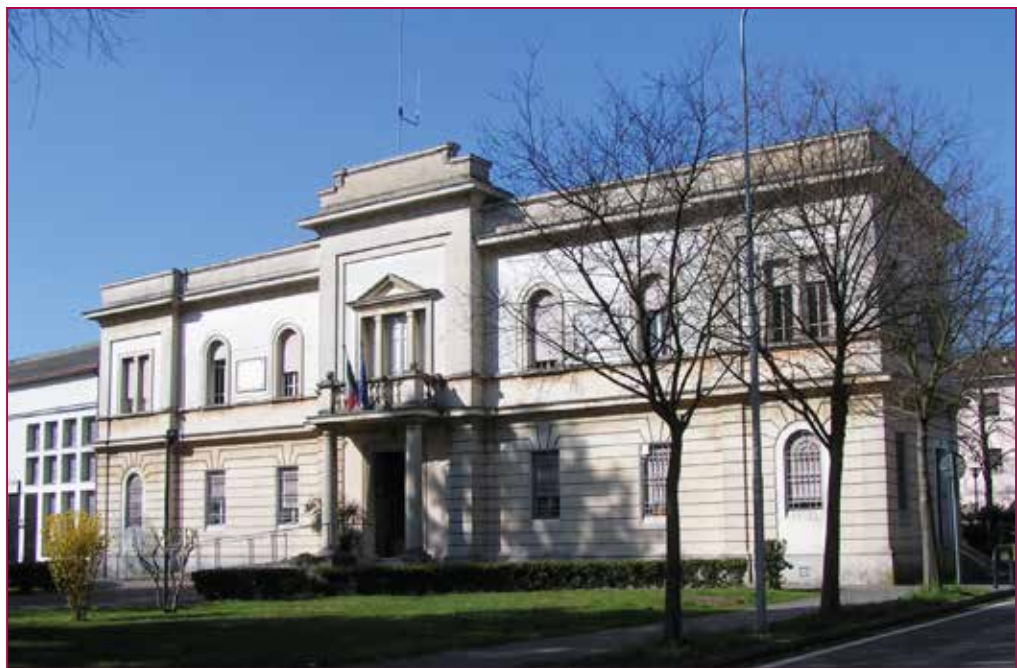
Fig. 1 - The main front of Camposanto city hall before the restoration works (photo Boschetti 2010).

The contribution aims at illustrating the role of direct observation and instrumental analysis in the conservation and restoration project of Camposanto city hall, a XX century monument hit by seismic events during the 2012 Emilia’s earthquake¹ (Fig. 1).

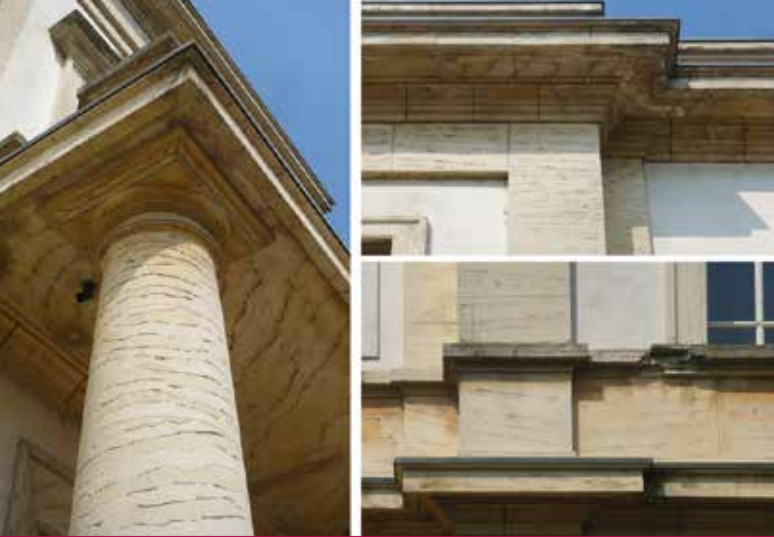
Fig. 4 - Columns, frames and other architectural elements finished with decorative concrete simulating travertine (photo Alvisi 2014).

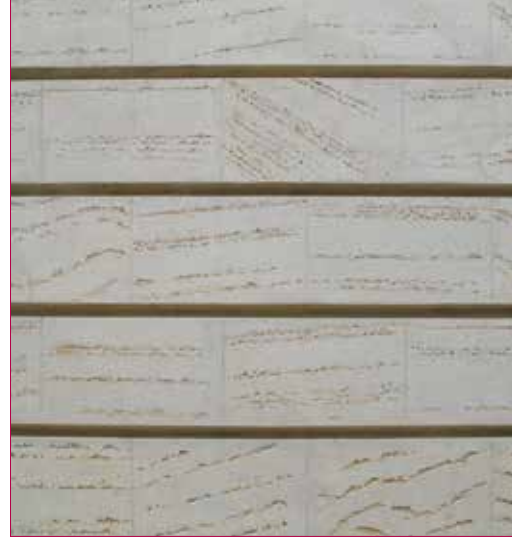
Fig. 5 - Decorative concrete finishing detail (photo Alvisi 2014).

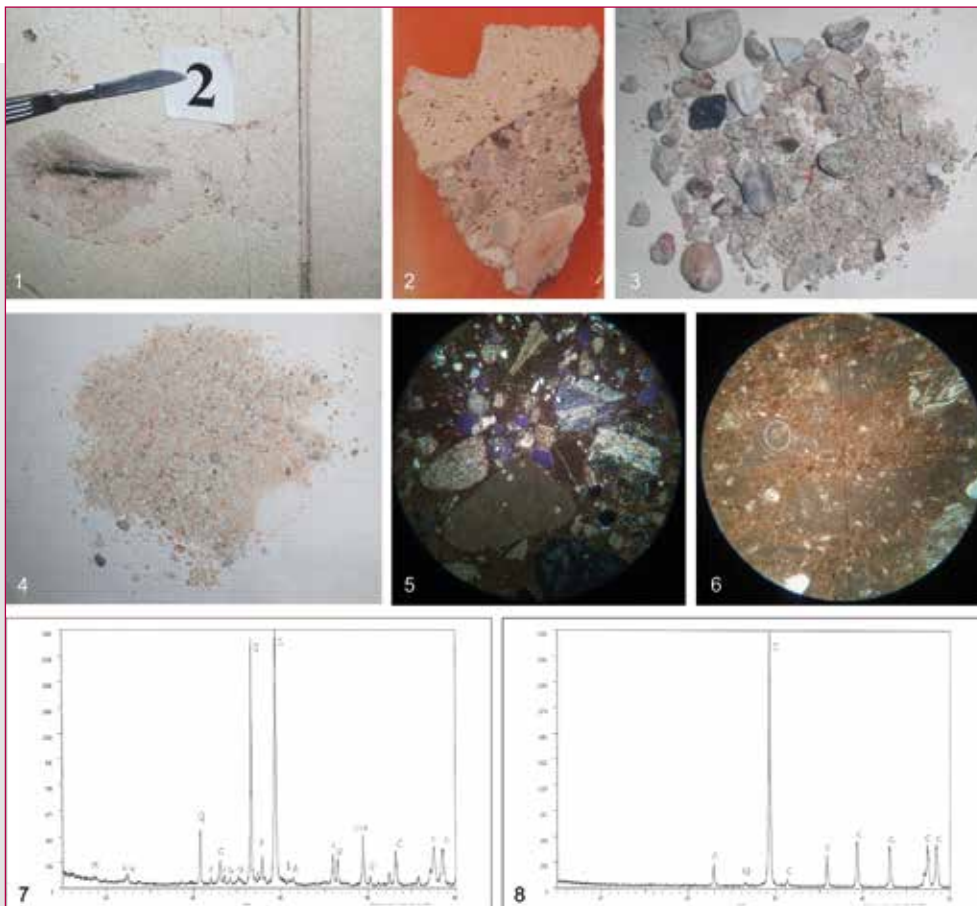
These investigations let a scientific characterisation of the preparation mortars and the superficial finishing and provided information on the techniques used to carry out architectural elements and mouldings. The decorative concrete analysis (Fig. 8) highlighted two layers of different materials: the inner one, grayish and the external one, off-white. The first is a mortar made with lime and a plentiful amount of cement. The aggregate is composed by fluvial sand with conglomerate or sandstone particle size and granules rounding; the mineral composition presents quartz, feldspar, carbonate with metamorphic fragments of mica-schist, gneiss, ophiolite, and sedimentary fragments of pelite and marl.

The off-white external layer is composed by a hydraulic lime grout with sharp edged and average-thin particle sized carbonate aggregate. The fragments are obtained by the milling of sedimentary limestone rocks (artificial chippings);

these consist of micro-crystalline and micritic limestone (like *Pietra d'Istria*) and biomicritic sandstone with Jurassic fossilized microfauna (as *Biancone* and *Bianco di Verona*). The information obtained from the laboratory analysis had been useful to guide, from the perspective of physical and chemical compatibility, the preparation of the restoration mortars for the lacunae integration.

Fig. 8 - 1. Decorative concrete plaster/mortar sampling (sample n. 2); 2. sample stratigraphy: grayish inner layer (below) and off-white external layer (above); 3. grayish layer: sandy-conglomerate aggregate separated from the binder; 4. off-white layer: micro-chipping aggregate separated from the binder; 5. grayish layer: crossed nicols thin section (4x); 6. off-white layer: parallel nicols thin section (4x); 7. grayish layer: diffractogram (C = calcite, Q = quartz, F = feldspar, D = dolomite, M = mica, Se = serpentine, Cl = chlorite, A = afwillite); 8. off-white layer: diffractogram (C = calcite, Q = quartz).

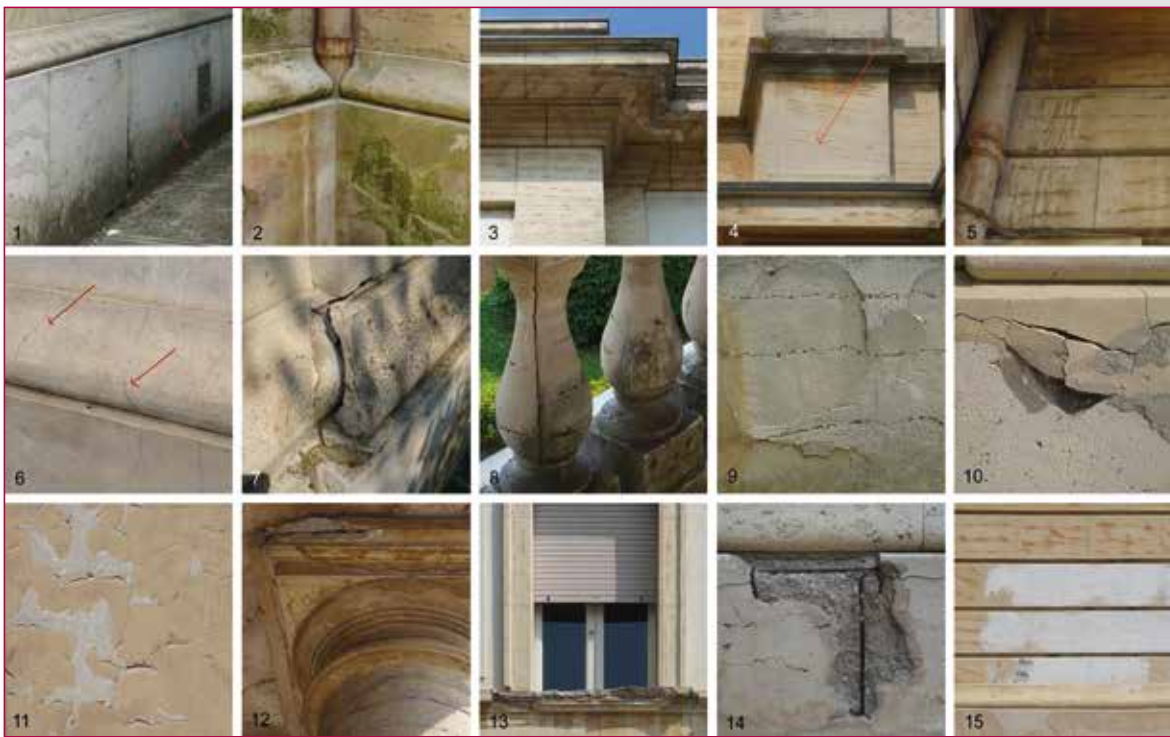
The degradation forms had been classified depending on the effects produced; the evaluation was based on visual and sound inspections, with the aid of optical instruments and percussion on alleged swellings. Providing a synthesis of what was detected, the degradation forms identified can be gathered in three typologies (Fig. 9):

- ▶ material deposit: incoherent, cohesive, biological (moss and lichens), scaling and inappropriate anthropic addition;
- ▶ material removal: finishing pulverisation, run-off, erosion, lacunae development and lack of whole architectural or decorative elements;
- ▶ irreversible shape alteration: superficial and deep cracking, break in continuity, paint layers or decorative concrete swelling, detachment of material layers from each other or from the wall, shelling and iron oxidation.

Fig. 9 - Summary of the degradation forms observed on the city hall facades: 1. superficial deposit; 2. biological coating; 3. scaling; 4. pulverisation; 5. run-off; 6. superficial cracking; 7-8. deep cracking; 9. swelling; 10. detachment; 11. paint layer detachment; 12. lacuna; 13. whole element lack; 14. iron oxidation; 15. inappropriate anthropic addition (photo Alvisi 2014).

- ▶ incoherent deposits: dry removal with soft natural bristles brushes and vacuums;
- ▶ coherent deposits and scaling: removal with sponge and water;
- ▶ biological coating, moss and lichens: appropriate biocide application limited to the attacked area and following accurate surface washing with low-pressure deionised water;
- ▶ inappropriate anthropic addition: removal with caution to avoid damaging the surface;

- ▶ superficial and deep cracking: grouting with a low saline hydraulic mortar prepared on site on the basis of laboratory tests results and coloured with the addition of organic and chemically stable pigments; application in layers where necessary and, after the first hardening, sponging with deionised water and sea sponge in order to expose the aggregate; sealing kept at the same level of the surface to facilitate the water outflow;
- ▶ detachment and shelling: attachment of the parts in risk of falling with stainless steel or fiberglass pins or annealed steel strings in relation to the element size;
- ▶ iron oxidation: cleaning, application of rust restraint agent and reconstruction of the lacking part;

- ▶ lacunae: integration with hydraulic mortar (same composition of the mortar described for the cracking) with aggregates characterised by particle size decreasing from the deeper to the more superficial layers. Verifying the new mortar-existing surface compatibility, to avoid the cracking and detachment of the new material because of the diversified reduction. A number of attempts on site led to the desired superficial effect, similar to the original one for colour and texture. The following stratigraphy had been applied (from the inside out): hydraulic mortar made with lime and eco-pozzolana; hydraulic mortar containing sand and brick shards: lime and marble powder bedding (2 parts of lime, 1 part of sand, 1 part of white marble and 1 part of yellow marble); superficial finishing with white marble⁶;

- ▶ lack of whole elements: application of rust restraint agent, first layer of mortar with a composition such as to give structure to the element, second layer of lime mortar and the same finishing described for lacunae. This procedure had been carried out for the reconstruction of original geometries with at least 3-4 cm of thickness;

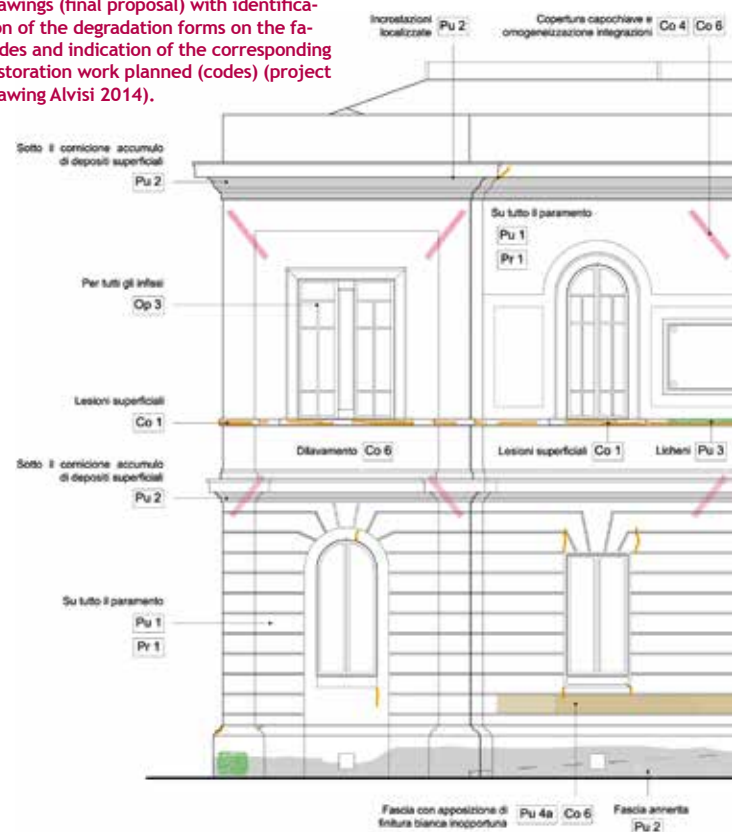
Fig. 10 - Extract of the restoration project drawings (final proposal) with identification of the degradation forms on the facades and indication of the corresponding restoration work planned (codes) (project drawing Alvisi 2014).

On the basis of the interpretation of analysis outcomes, the city hall facades had been considered subject both to physiological degradation of materials exposed to time and weathering and to the lack of maintenance. The goal established consisted of treating the issues observed but also removing to the root the causes identified, where possible. Preceded by appropriate tests done on sampling areas for the calibration of executive parameters, the works carried out on the municipal hall facades are here summarised (Fig. 10).

- ▶ verifying elements stability and plaster adherence to the wall through knocking on the surface; following manual removal or attachment of the detaching parts with provisional work, temporary sealing, prop or bandage as appropriate;
- ▶ verifying rainwater outflow efficiency and replacement of the damaged elements in order to prevent water leak and percolation on the surfaces;
- ▶ doors and windows protection before cleaning;

4) protection: superficial treatment based on siloxanes, water resistant and colourless.

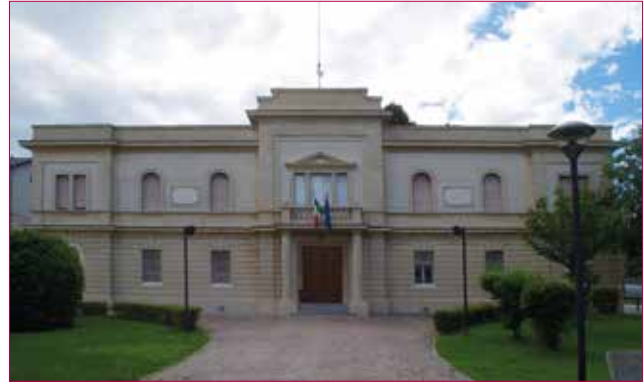
The works on Camposanto city hall have been carried out in spring 2016 (Fig. 11). The direct observation of the monument and the interpretation of its values highlighted the significant role of its decorative concrete finishing. The implementation of instrumental analysis, accurately chosen due to the information needed about materials and compositions, completed the information-gathering studies, providing the basis for the elaboration of a conscious and coherent conservation project. Therefore this experience shows an interesting example of XX century architecture restoration, a topic not yet systematically studied and for which accepted methodologies are neither widely shared nor consistently adopted.

Fig. 11 - The main front of Camposanto city hall after the restoration works (photo Alvisi 2016).
